Review of Gully Erosion in Anambra State: Geology, Causes, Effects, Control Measures and Challenges Associated with Its Mitigation

Mini-review Article

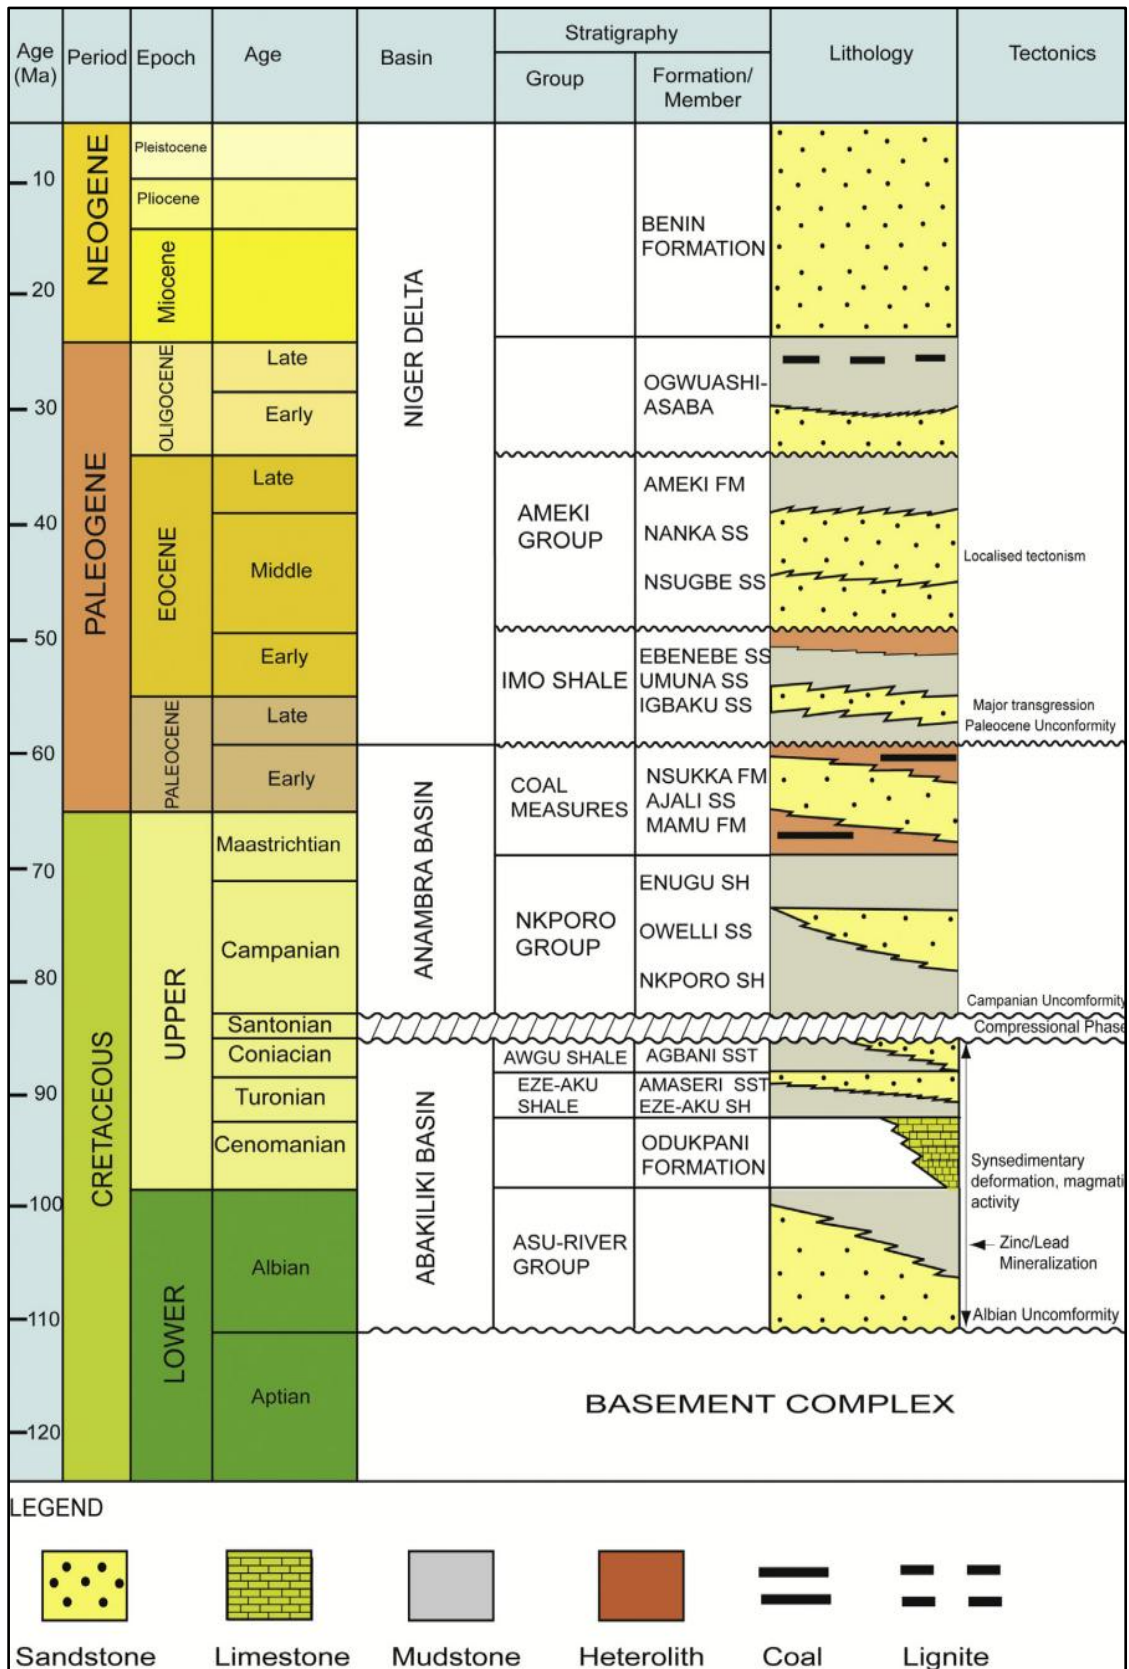
Fig. 3. The stratigraphic succession of the Anambra Basin and the Niger Delta [37]

The geological setting in the study area is that of layered sequences in which a predominantly sandstone formation (Ameki group) is underlain by a predominantly shale formation (Imo shale) [1,36,37,24].

Stratigraphic succession in the Anambra Basin and Niger Delta Basin (redrawn and modified from [24,38,37,27].

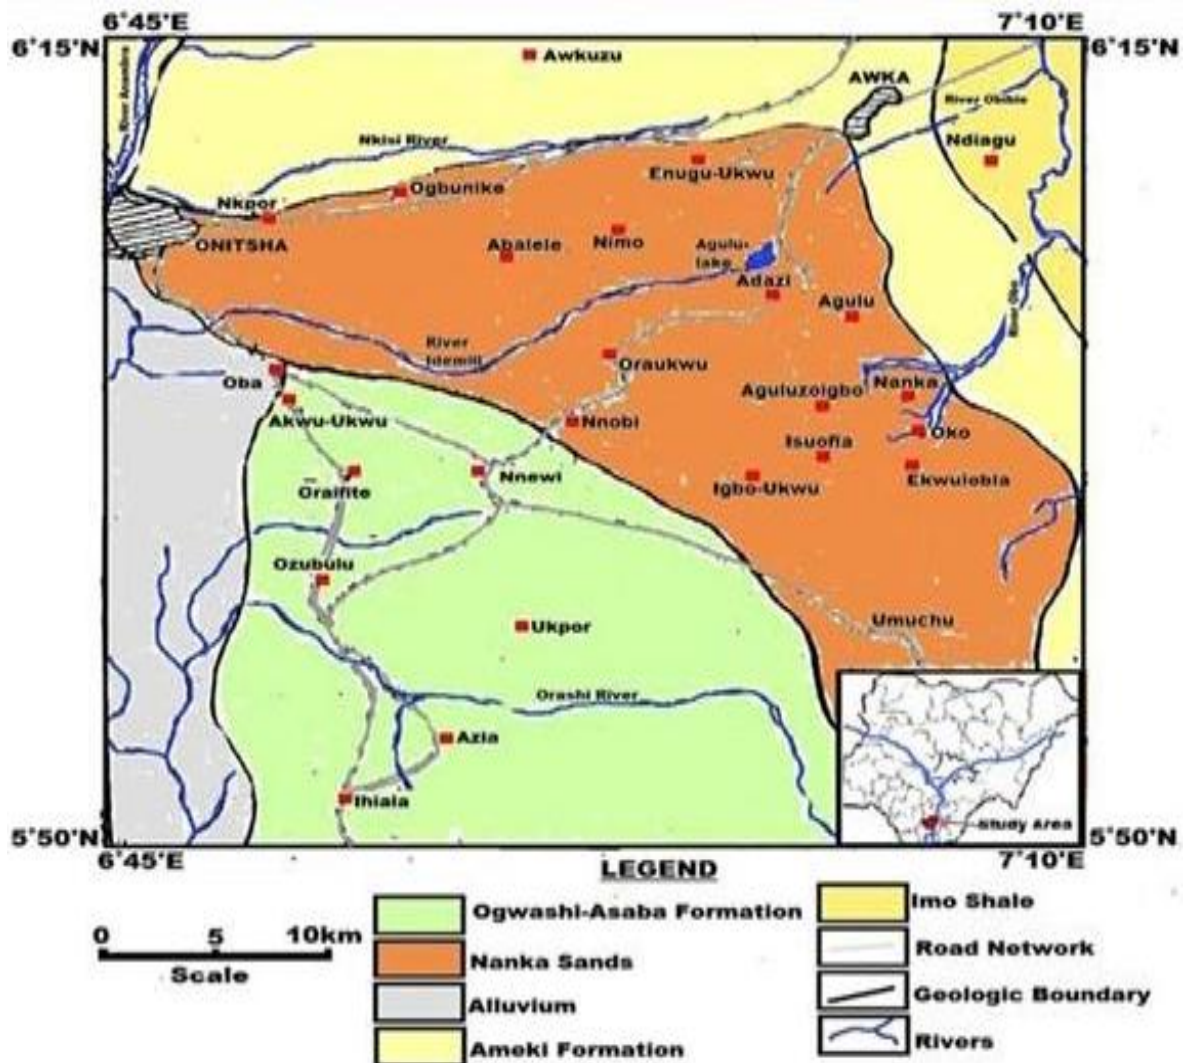
Fig. 4. Geologic map showing the geology of the study area [41]

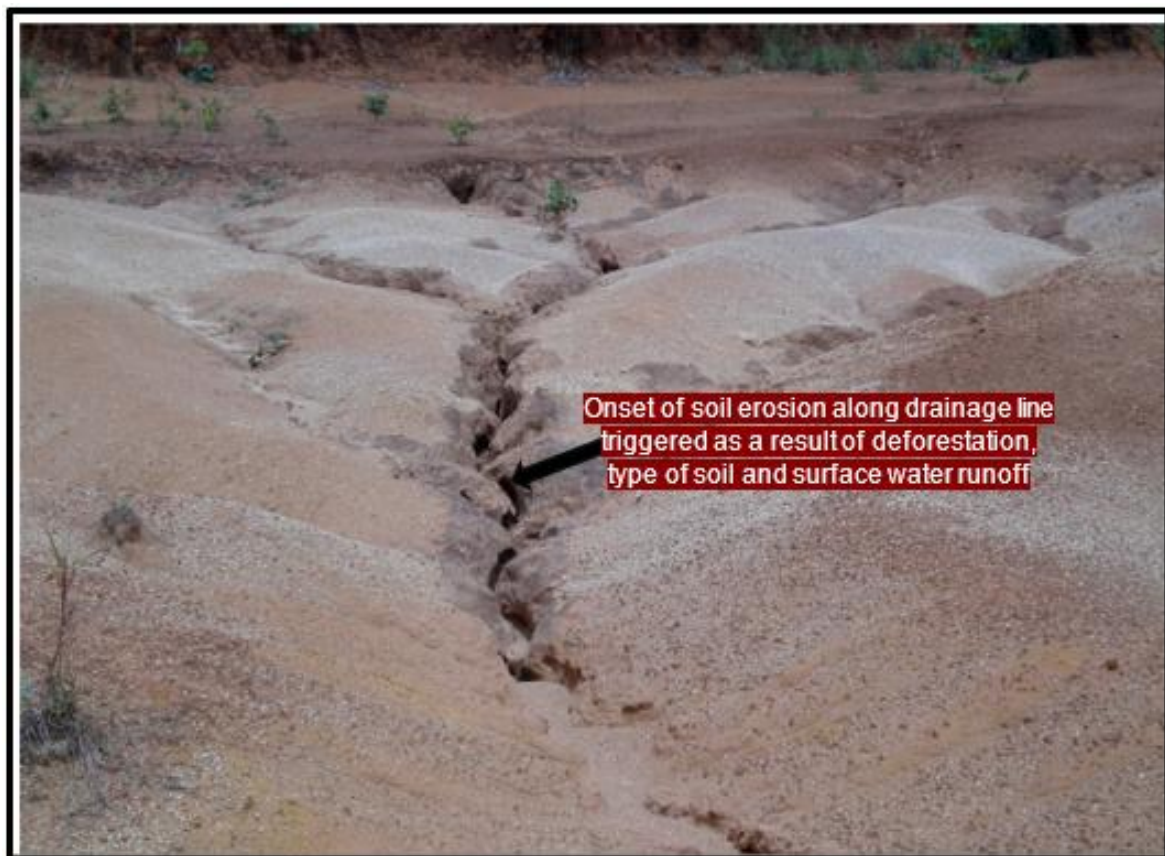
Fig. 5. Onset of gully erosion triggered by deforestation and topsoil excavation [1]

When deforestation occurs, the soil is left exposed to the elements and rainfall. This can lead to soil compaction and erosion along drainage lines [1,7]. Soil becomes more erodible as compaction increases, as it reduces water infiltration and increases surface runoff [1,7]. This indicates that the soils in Anambra state meet the Federal Government's requirements for non-weak soils. However, high compaction values in the state indicate a high susceptibility to erosion. As compaction increases, so does a soil's erodibility and bulk density [8].

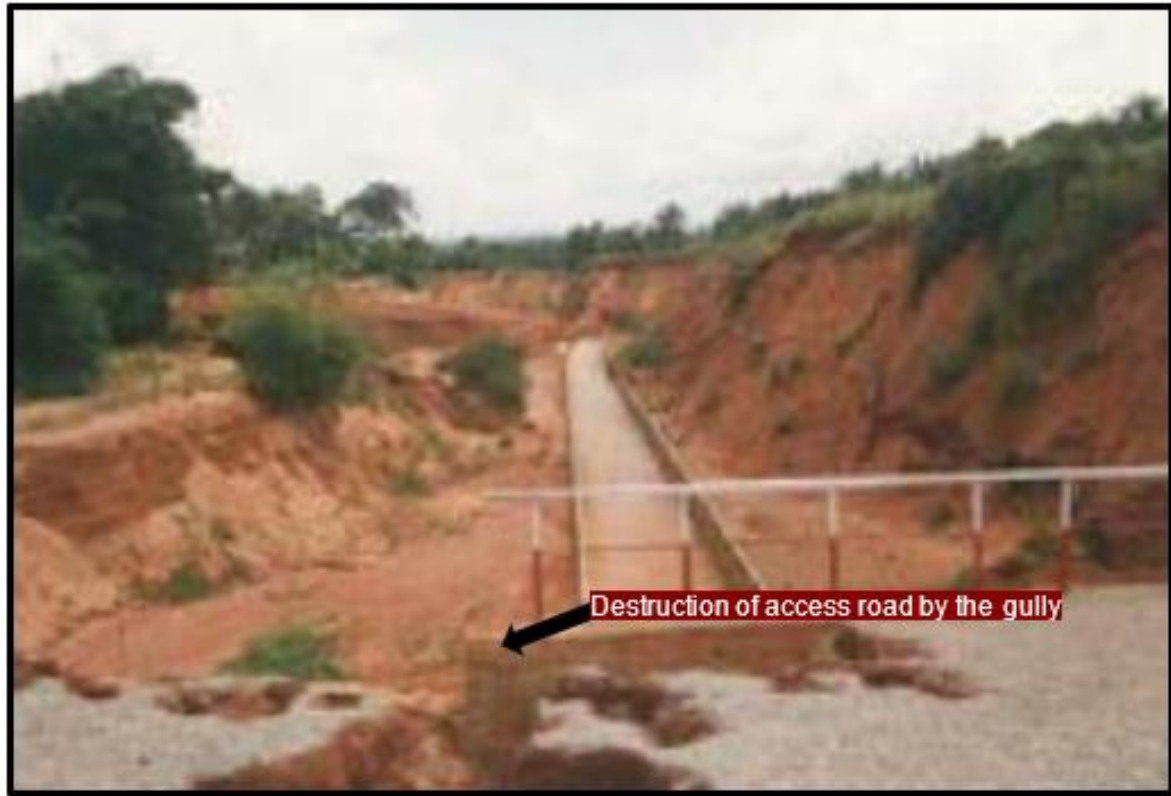
Fig. 6. A Gully Site in Umuchiana, Aguata, showing the dissection of the access road [12]

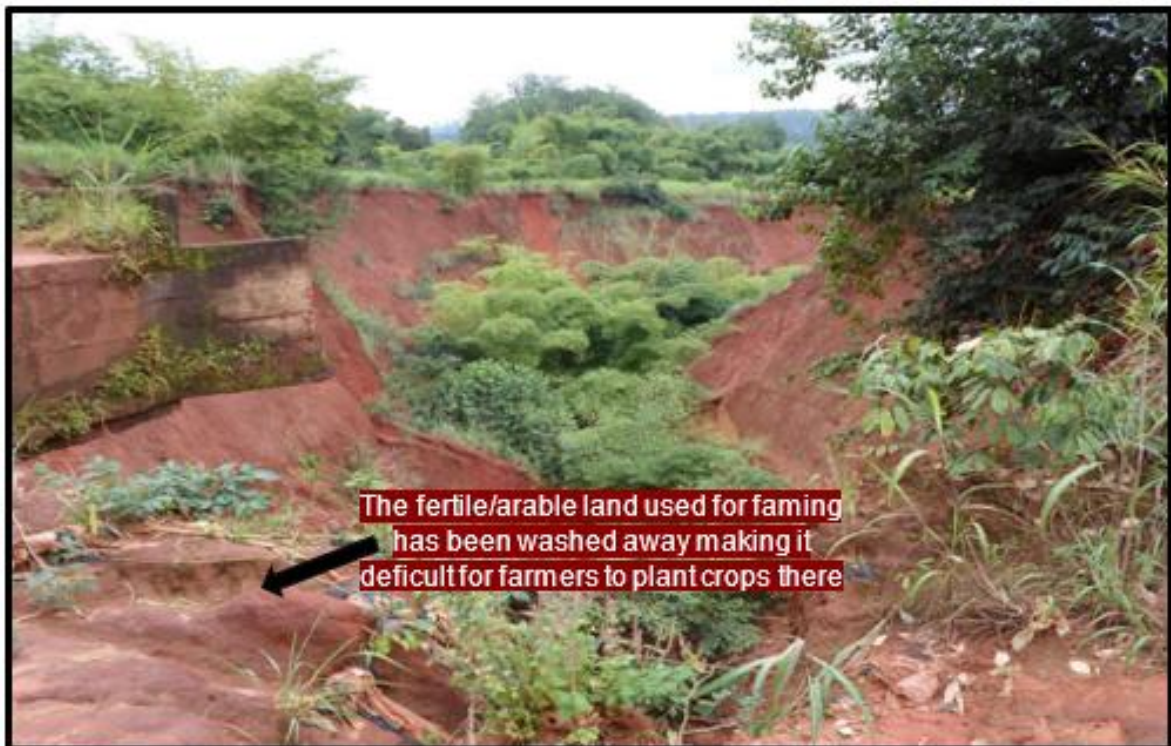
Fig. 7. Gully site at Obinagu village showing loss of productive land [7]

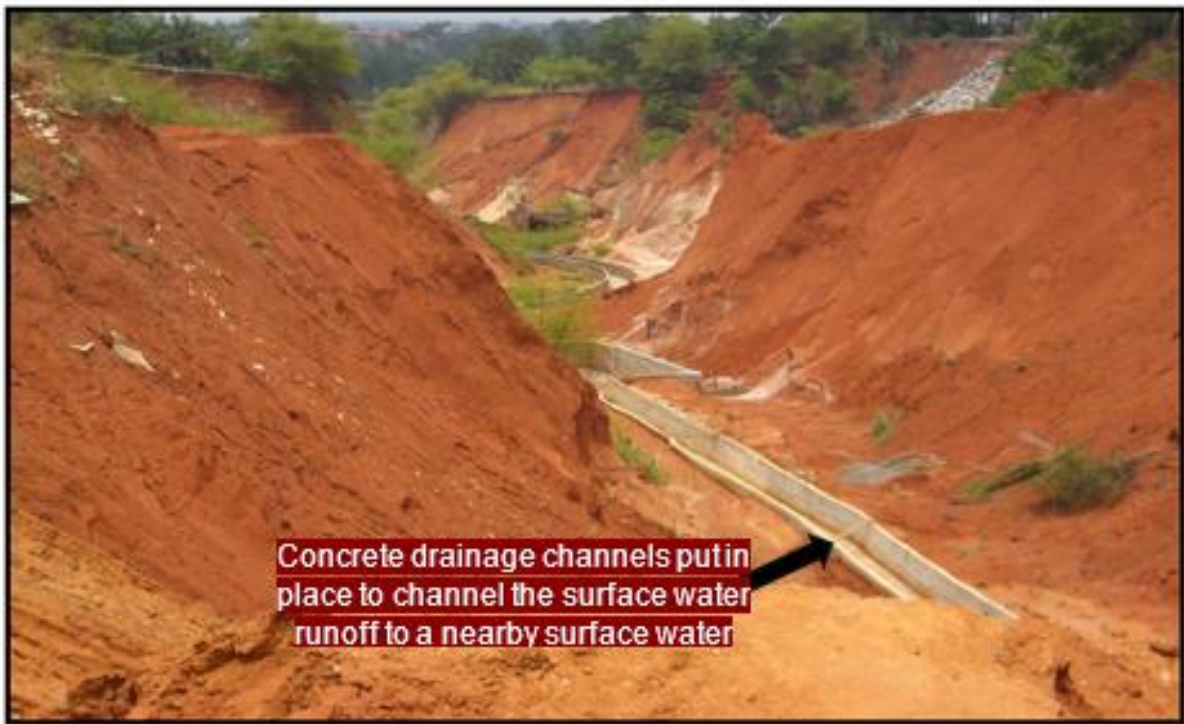
Fig. 8. Control measure put in place to check gully erosion [1]

In order to effectively control gully erosion, two approaches need to be taken: addressing issues in the catchment and stabilizing the gully walls. Civil engineering works such as constructing concrete embankments and grouting can stabilize the walls [1]. To prevent developers from erecting structures along natural drains without appropriate channelling or alternative drains, it is recommended to enact and enforce necessary legislation [15]. Workshops, seminars, and symposiums should be organized to educate communities in Anambra state, while environmental campaign awareness, construction of stormwater sock away, good farming practices, and construction of control dams, ditches up the valley, and earth dams of adequate capacity should be encouraged [10].

Applying simple grouting and stabilization at an early stage of development can effectively control gullies [1]. Pipeline structures can be used to control excess runoff and channel water to nearby surface water. Materials used for
