Effect of Physiological Loading on Fretting Corrosion of Zimmer® Trabecular Metal™ Coupled Tibial Cones Interacting with Tibial Baseplates

Original Research Article

Aim: To evaluate possible micromotion between the existing design of the Zimmer® NexGen® Legacy Constrained Condylar Knee (LCKK) tibial baseplates and the Zimmer NexGen Trabecular Metal™ (TM) tibial augments, as well as with newly designed Zimmer NexGen LCKK TM coupled

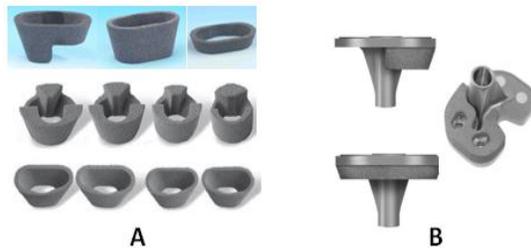
Fig. 1. (A) TM tibial cone augments (B) TM tibial augments/half-augments

The Zimmer® NexGen® Trabecular Metal™ (TM) tibial augments (TM tibial augments or half-augments) are designed to help replace and/or augment proximal tibial bone loss. The TM tibial augments are assembled to the distal (undersurface) of the NexGen Legacy Constrained Condylar Knee (LCKK) tibial baseplate using tibial attachment screws and/or bone cement. The *Zimmer NexGen Trabecular Metal* tibial cone augments (TM tibial cone augments), were designed to fill major cavitory or combined cavitory and segmental bone defects. The tibial cone augments provide solutions to a variety of proximal tibial bone defects encountered clinically [2,3]. These augments enhance fixation to the damaged metaphysis and provide a stable platform for the associated *Zimmer NexGen* tibial baseplate [4,5]. Both the TM tibial cone and tibial augments (Figs. 1A-B) are intended for use

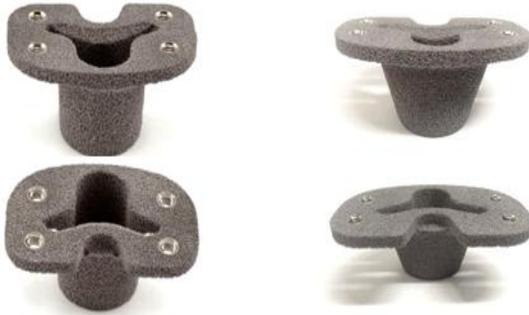
Fig. 2. TM tibial coupled cone augments

The newly designed *Zimmer NexGen LCKK Trabecular Metal* Coupled Tibial Cone (TM coupled tibial cone augment) intends to combine the function of both the TM tibial augments and the TM tibial cone augments. The TM coupled tibial cone design (Fig. 2) uses the same cavitory filling geometries as the TM tibial cone augments and the mating functions of the TM tibial augments. It consists of TM implants to specifically address small to medium segmental, contained cavitory defects found during revision surgery of the proximal tibia. It provides for mechanical attachment between the TM component and the tibial baseplate to allow for modularity as well as intraoperative
