Original Article

Galvanic Corrosion of and Ion Release from Various Orthodontic Brackets and Wires in a Fluoride-containing Mouthwash

J Dent Res Dent Clin Dent Prospect 2015; 9(3):159-165 | doi: 10.15171/joddd.2015.030

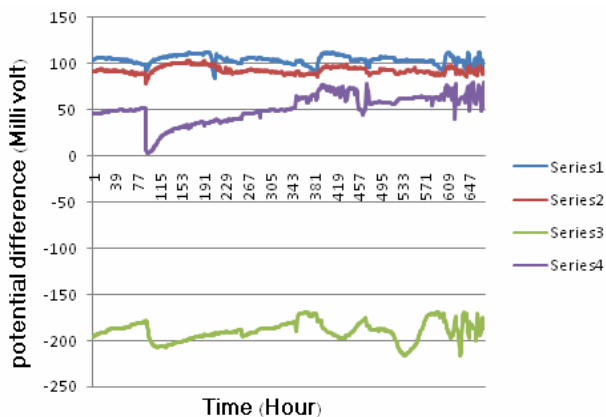
Figure 1. The mean EP differences (in millivolt) obtained from the coupling of NiTi wire with different brackets: (1) Dentaurum; (2) American Orthodontics; (3) Shinye; and (4) ORJ brackets.

The differences in EP between samples with Shinye brackets were significantly lower than those of other brackets. In fact, the EP difference for Shinye brackets was negative, in contrast to those of other samples (Figure 1).

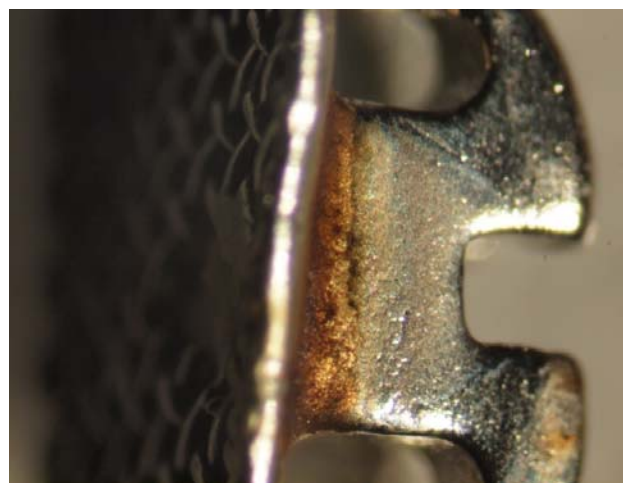
Figure 2. Stereomicroscopic micrograph (×3) of ORJ bracket from group 8 (ORJ bracket & SS wire) after testing.

In samples with SS wires, only the coupling of ORJ brackets and SS wires showed obvious alterations, which were similar to changes observed in the coupling of ORJ brackets with NiTi wires (Figure 2).

The amount of iron ions released from ORJ samples was greater than the amount released from other brackets. Furthermore, in stereomicroscopic micrographs of these brackets it is observed that the surface of these brackets, especially at the location of the O-ring, has a distinct yellow discoloration which can be attributed to the rusting of these brackets.

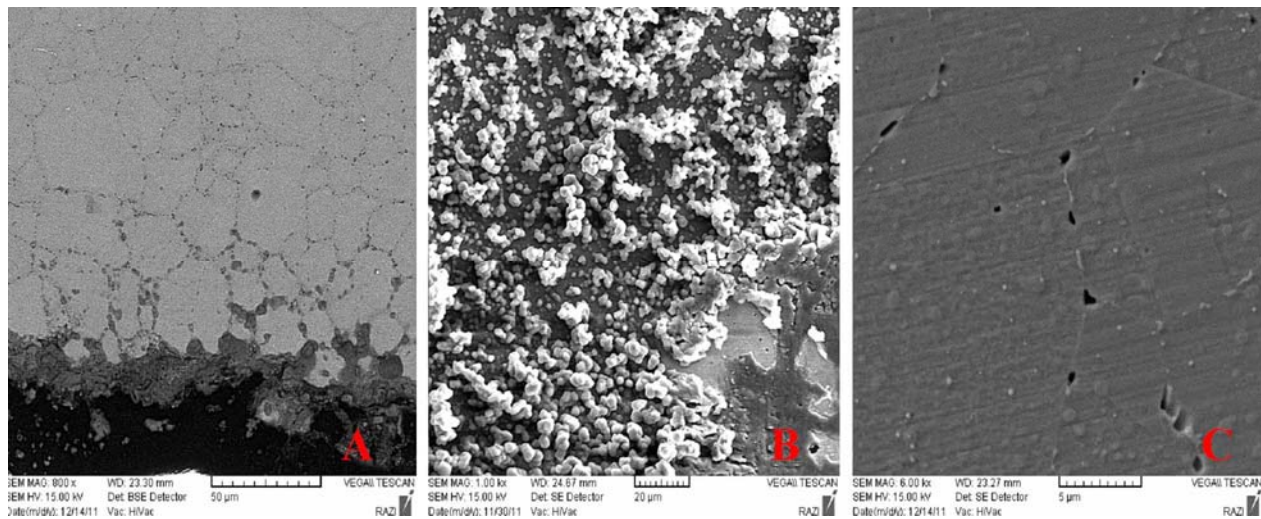
Figure 3. SEM micrograph of ORJ bracket at the location of O-ring from group 8 (ORJ bracket & SS wire): a) after testing and before irrigation ($\times 1000$); b) after testing and irrigation ($\times 800$); c) after testing and irrigation ($\times 6000$).

See Figures 3A, 3B and 3C. Materials observed on the surface of ORJ brackets, after coupling with SS wire and placement in the electrolyte solution, were the products of electrochemical corrosion that appeared yellow under the light microscope. Pitting and intergranular corruptions were also noticed.

On SEM micrographs of Dentaureum brackets, a uniform corrosion was observed on the wing surface of the bracket, whereas on SEM micrographs of ORJ brackets, severe crevice corrosion was observed at the location of O-ring. This type of corrosion occurs when two surfaces are in close contact with each other in low-oxygen conditions, increasing the corrosion on the surface of SS brackets and resulting in salt formation on the surface and release of Fe, Cr and Ni ions from the metal.^{3,18,19} Intergranular corrosion is also observed on the surface of these brackets that can lead to staining of SS brackets followed by their weakening and eventual fracture.

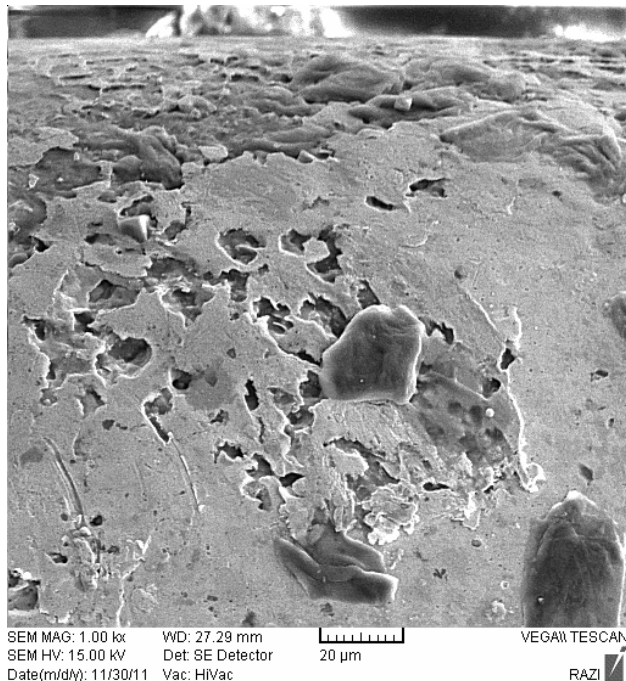
Figure 4. SEM micrograph of ORJ bracket at the location of O-ring from group 4 (ORJ bracket & NiTi wire) after testing and irrigation ($\times 1000$).

Some surface defects observed before testing on the brackets were due to their manufacturing process. After testing, pitting corrosion, surface corrosion and numerous defects were observed on the surface of ORJ brackets in the area attached to NiTi wire (Figure 4).
